Subject:	IA20200713a Integrity Crosstrainer - gap between Pedal Roller and Gap Control Bracket				
Product Brand: Life Fitness	Product Market Segment: <input checked="" type="checkbox"/> Commercial <input checked="" type="checkbox"/> Consumer		Organizational Distribution: <input checked="" type="checkbox"/> LF Subs <input checked="" type="checkbox"/> ISO's/IIO's <input checked="" type="checkbox"/> Distributors <input checked="" type="checkbox"/> Dealers <input type="checkbox"/> Customers		
Time Required:	<input type="checkbox"/> No Time <input type="checkbox"/> 5 Min <input type="checkbox"/> 10 Min <input type="checkbox"/> 15 Min <input checked="" type="checkbox"/> 30 Min <input type="checkbox"/> 45 Min <input type="checkbox"/> 1hr <input type="checkbox"/> 1,5hr <input type="checkbox"/> 2hr <input type="checkbox"/> 2hr+				
Problem Code:	-	Internal Reference:	FIELD00BC-746	Affected region:	Global

Doc. Number: IA20200713	Doc. Revision: a	Doc. Revision Date: 2020-07-13	Pages: 1	Author: Fran Keijmes	Departmental Distribution: <input checked="" type="checkbox"/> Installation <input checked="" type="checkbox"/> Service <input type="checkbox"/> Sales
<small>Life Fitness proprietary and

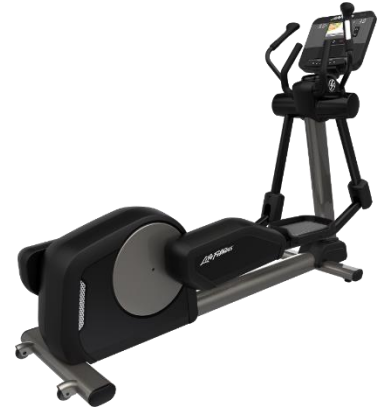
Some reports have been received about noises coming from the back of the Life Fitness Integrity Crosstrainers shortly after installation, whereby it was discovered that the Pedal Roller was touching the Gap Control Bracket.

It is advised to follow the inspection procedure during installation in the coming 2 months and report back any Serial Numbers whereby the inspection fails. (Which means there is NO gap found between the Roller and the Gap Control Bracket)

Whenever a product does not pass the inspection, please review the following video "How to CORRECT the gap between the Roller and Gap Control Bracket" and correct the issue accordingly.
