Subject:	IA20201006a – LF Optima Strength - incorrect Cable Retainer				
Product Brand: Life Fitness	Product Market Segment: <input checked="" type="checkbox"/> Commercial <input type="checkbox"/> Consumer		Organizational Distribution: <input checked="" type="checkbox"/> LF Subs <input checked="" type="checkbox"/> ISO's/IIO's <input checked="" type="checkbox"/> Distributors <input checked="" type="checkbox"/> Dealers <input type="checkbox"/> Customers		
Time Required:	<input type="checkbox"/> No Time <input checked="" type="checkbox"/> 5 Min <input type="checkbox"/> 10 Min <input type="checkbox"/> 15 Min <input type="checkbox"/> 30 Min <input type="checkbox"/> 45 Min <input type="checkbox"/> 1hr <input type="checkbox"/> 1,5hr <input type="checkbox"/> 2hr <input type="checkbox"/> 2hr+				
Problem Code:	-	Internal Reference:	QHOLD-15	Affected region:	Global
Doc. Number: IA20201006	Doc. Revision: a	Doc. Revision Date: 2020-10-06	Pages: 3	Author: Fran Keijmes	Departmental Distribution: <input checked="" type="checkbox"/> Installation <input checked="" type="checkbox"/> Service <input type="checkbox"/> Sales

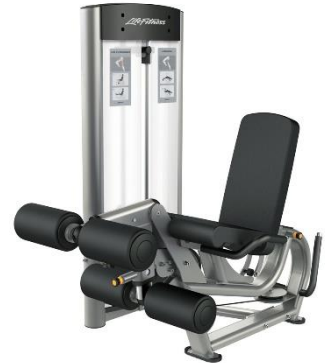
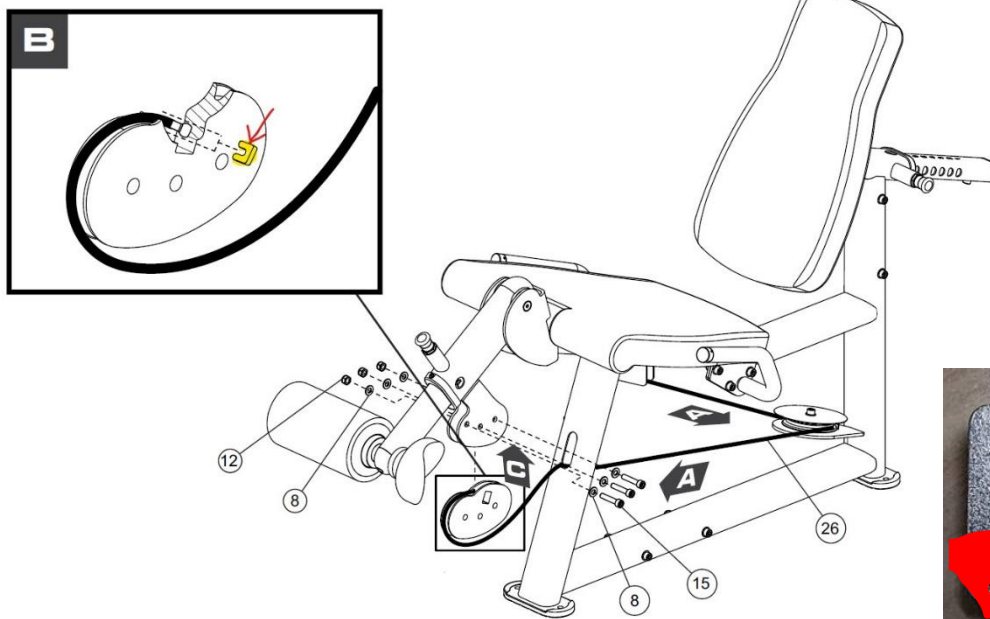
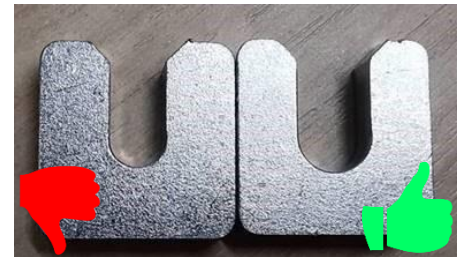
For a small range of Optima Strength products, it's possible that the wrong version Cable Retainer was included within the box. When this is the case, this means that the assembly of the product can't be finalized. The correct part is needed to be able to finalize the product assembly.

This Cable Retainer is located inside the Cam on the working arm and holds the end of the cable into place.

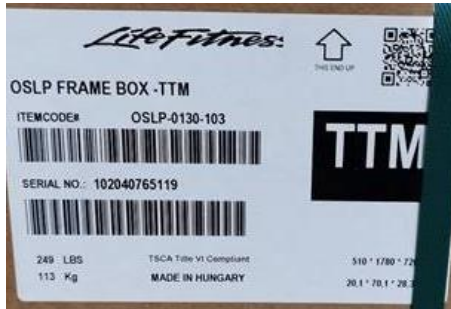
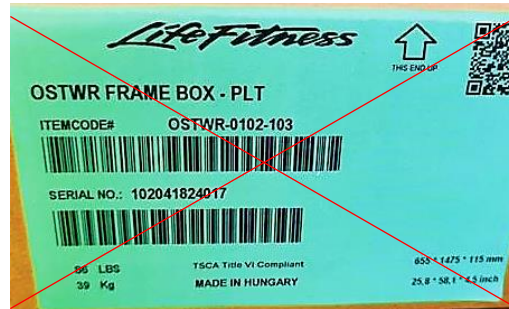
The Cable Retainer is only included in the "Frame box" (SKU: OSxx-01xx-103) with the white colored box label, not the "OSTWR" boxes with green colored labels. This means only White labeled "Frame Box" Serial Numbers are affected.

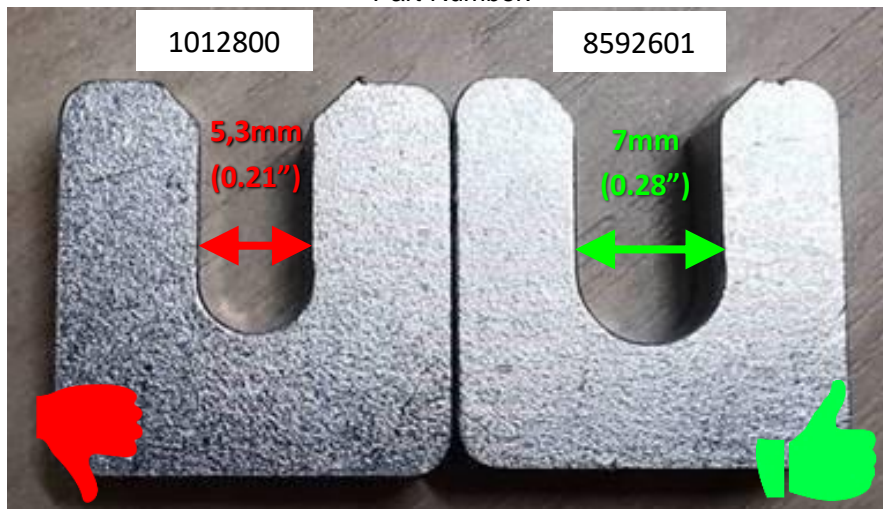
Part Number:

Measure the width of the inner cut out of the Cable Retainer. The correct width is 7mm (≈0.28 Inch). If the cut out is around 5,3mm (≈0.21 Inch) then the Cable Retainer is incorrect, which then needs to be replaced by the correct one (Part Number 8592601). The incorrect Cable Retainer can be disposed.
